Nedumudi Grama Panchayat

Disaster Management Plan

Nammal Nammukkai DISASTER MANAGEMENT PLAN- 2020

Name of the Panchayat	:	Nedumudi
Block	:	Champakulam
District	:	Alappuzha
Date	:	15.01.2020

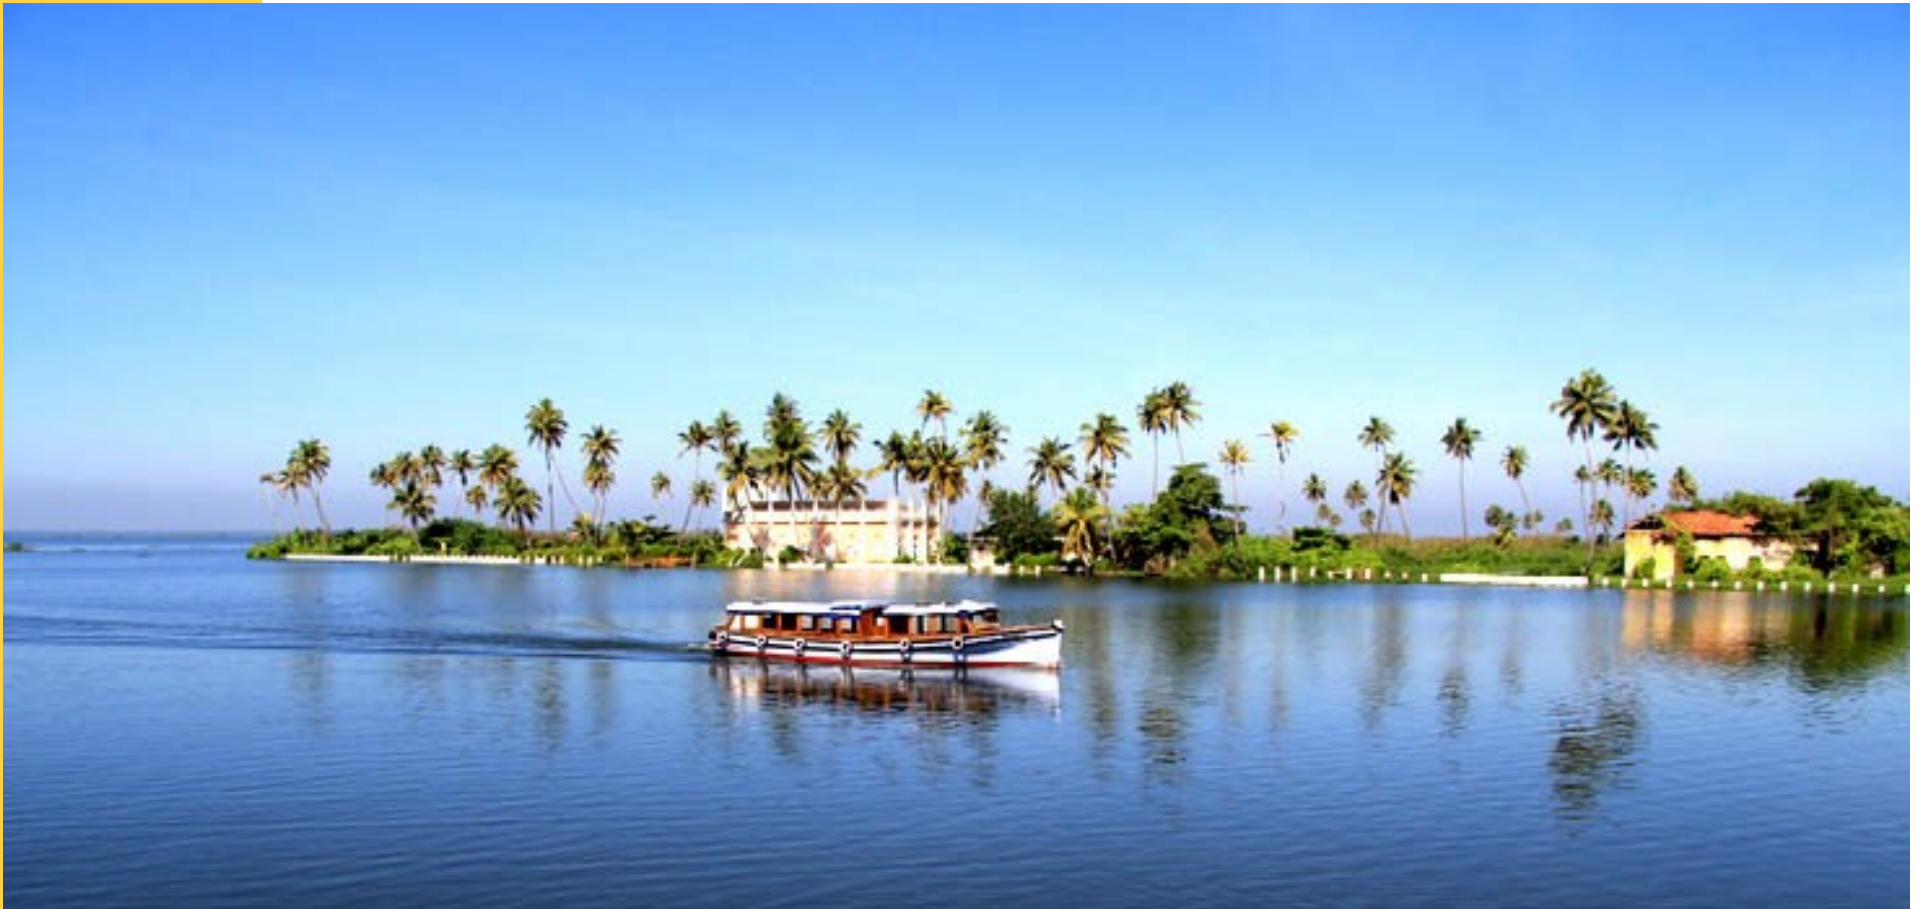
The key to disaster mitigation is to protect the soil, water, natural resources and natural boundaries of the area. Widespread encroachments, including rivers and streams, have taken place during this period. Earlier the main route for walking in this panchayat was the main street near Chambakkulam- Nedumudi river. From Kochupalli bridge to Paruthikalam bridge about 1.5 kms encroachment is found. Tourism resorts are completely occupied by the coast and is used as private property. The same situation appears on the banks of the tributary of Pookita River. It also provides a Google Earth map that provides a comparative analysis of how much encroachment of Riverside has been subjected to in the 25 years (1995 to 2020).

There are many obstacles in the tributaries that affect the natural flow of water.

- 1) The width and depth have decreased.
- 2) high eutrophication
- 3) Organic and inorganic wastes are deposited.

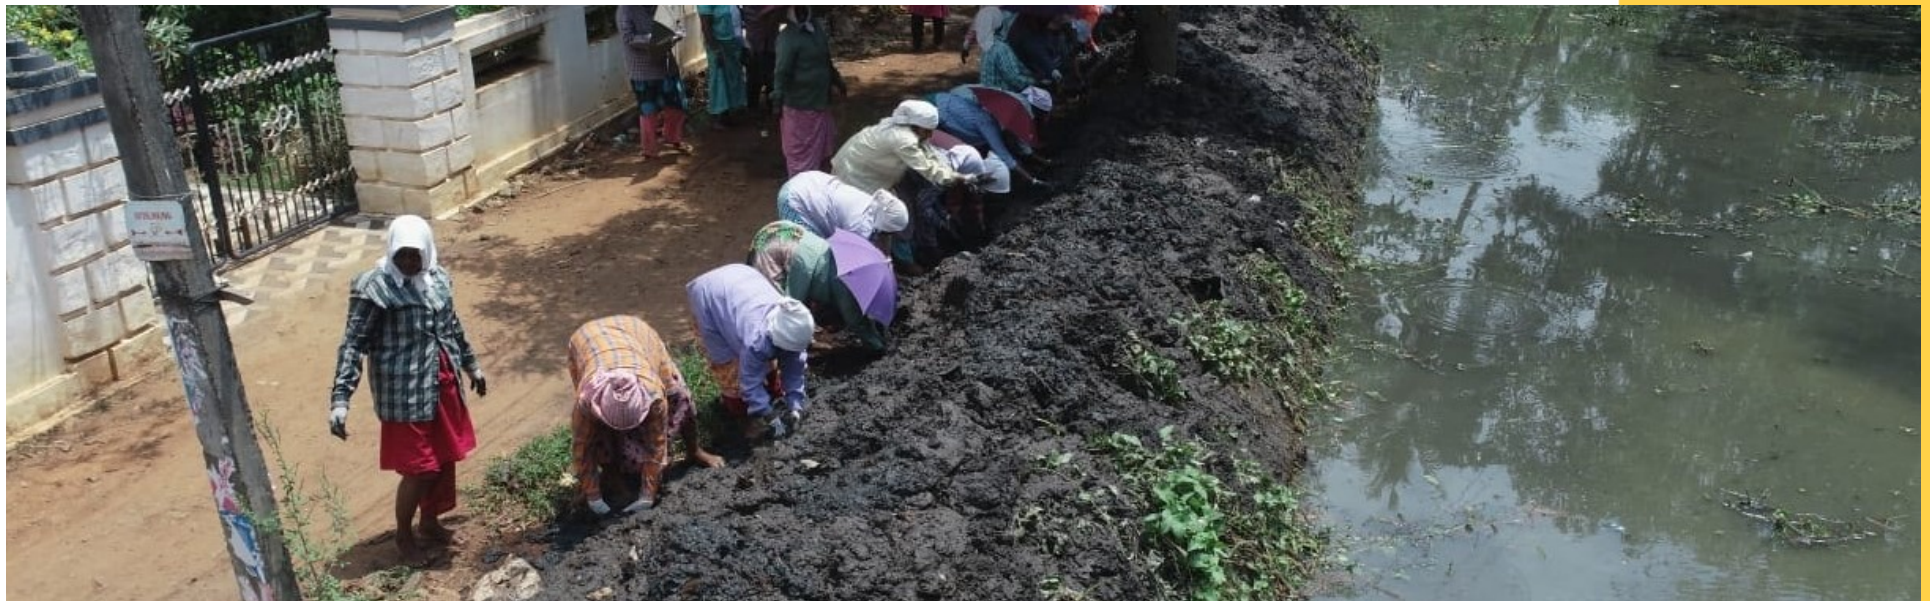
Nedumudi is a peninsula region surrounded by two rivers and has a canal stretch of 35.4 km inside its boundaries. Out of the total geographical area, only a few regions have human settlement and the rest of the area are either ponds, canals or paddy fields. Due to geographical peculiarities, the canal system is in such a way that the water flows towards the panchayat. Due to these characteristics of watershed in the region, in the portions other than the human habitations the water level in the region are upto the same level of water in the river.

The heavy rainfall during monsoon and the rainfall in the catchment area are the major reasons for floods in the entire Kuttanad region including Nedumudi. There was no possibility of flooding solely due to the rain from two monsoons. Even Though there are two rivers surrounded by Nedumudi, unlike Kainakari and Pulinkunnu, flooding due to the upstream river flow is not a challenge for Nedumudi .

As mentioned above, the two changes that have taken place during this time period have opened up the possibility of flooding in Nedumudi today. One important reason is climate change itself. The disaster probability map given by KSDMA (Map 1) implies that the entire panchayat is flood prone due to the water from upstream and the rainfall in the panchayat boundary. Heavy flooding, inadequate rainfall, barriers to drainage, delays in receiving rainwater due to the seawater characteristics, and rising sea level are the impacts of climate change. The last two decades in the region have seen a series of development programs and a change in people's attitudes creating another level of crisis. It is the system of canals and paddy fields in the area that helps in the flow of rainwater during monsoon. But at present in Nedumudi panchayath, the efficiency of this process has been greatly reduced.
